Home Inspections

A Home Inspection Report For the Exclusive Use of:

**9 Dream Lane
Jekyll Island, GA 31527**

July 9, 2006

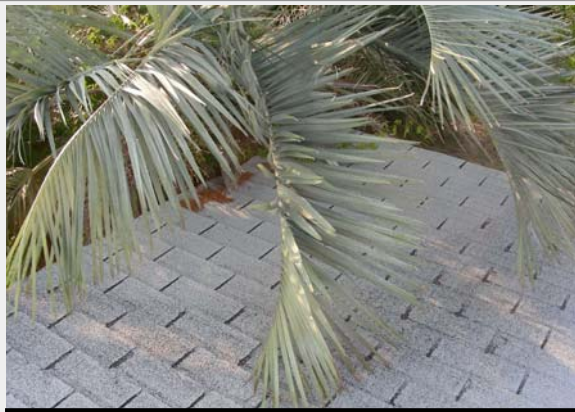
Trees Contacting Roof

- Landscaping needs attention. It has been neglected.
- One or more **trees are in contact with the roof or structure**. They should be trimmed to eliminate the possibility of damage. Palm trees are in contact with the roof at the back center, the back right corner and the front left corner.

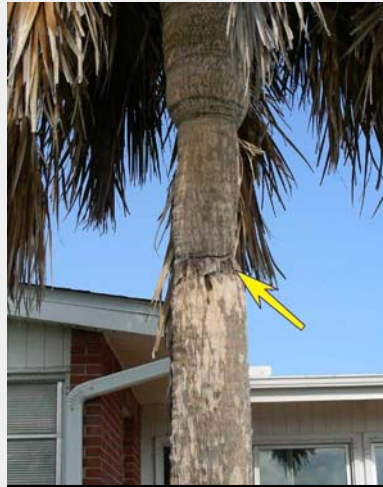
Weak or damaged Tree Trunk

- Some of the trees on the property **appear to be in poor health**. Recommend contacting arborist for evaluation. The palm at back patio appears to have a **weak or diseased spot** about 2/3 of the way up the trunk.

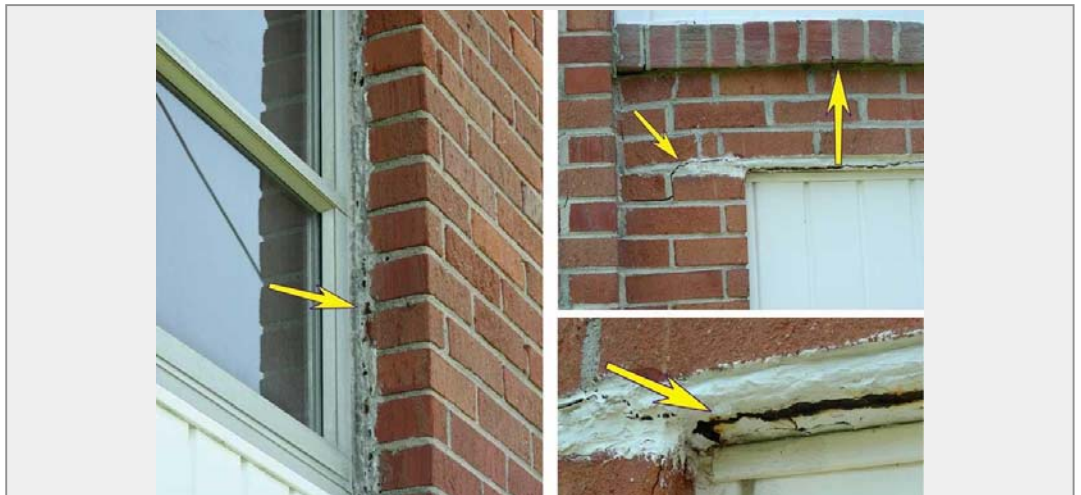
Bowed Brick / Rusted Lintel

- At the left side front corner of the living room, **the brick is bowed out and pulling away from the structure**. There is a **horizontal crack** about midway up and the brick can be seen **pulling away from the window frame**. This does not appear to be structurally significant at this time, but should be monitored periodically for changes. This bowing is the most likely cause for the unusual bump up of the brick ledge above the garage door. the heavily rusted lintel may also be related to the bowed brick.
- **The lintel over the basement doorway is heavily rusted and may need to be replaced.**

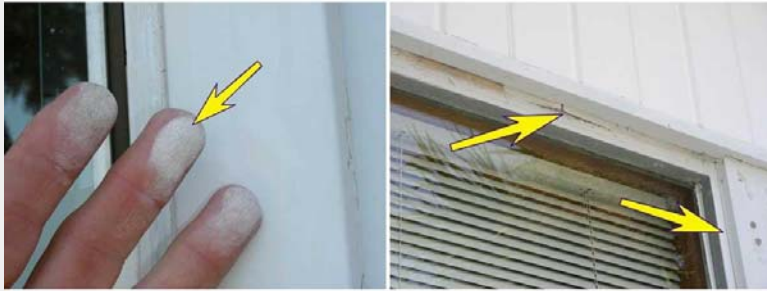
Worn Trim Paint / Sealing Needed at Joints

- **The trim needs painting.** Painted finish is very oxidized.
- The wood trim around the windows is clad in metal. **Some of the joints are not sealed.** This can allow water to enter under the metal, causing moisture damage. Recommend sealing all joints in the trim.
Additionally, the condition of the wood under the metal **cannot be evaluated.**

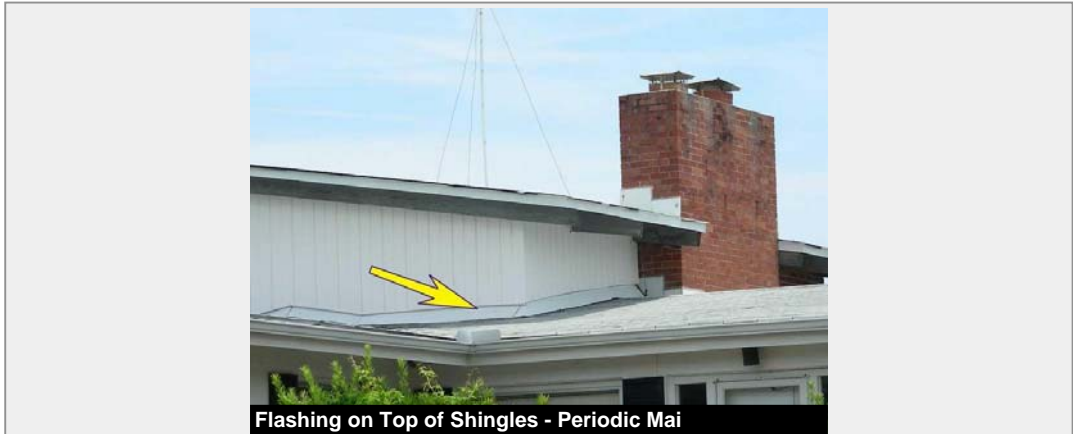
Roof flashings are **externally installed** and will need periodic maintenance. *Flashings properly installed will be under the siding and the roofing.*

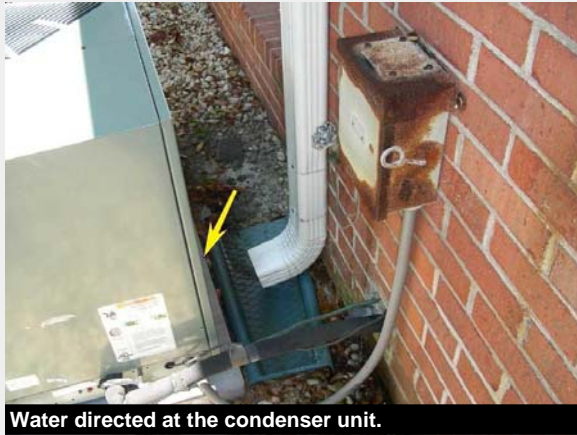
- It is recommended that a **diverter tube be added** to carry the roof run off well away from the structure at all downspouts. The downspout at the right front corner **dumps water directly toward the condenser.**

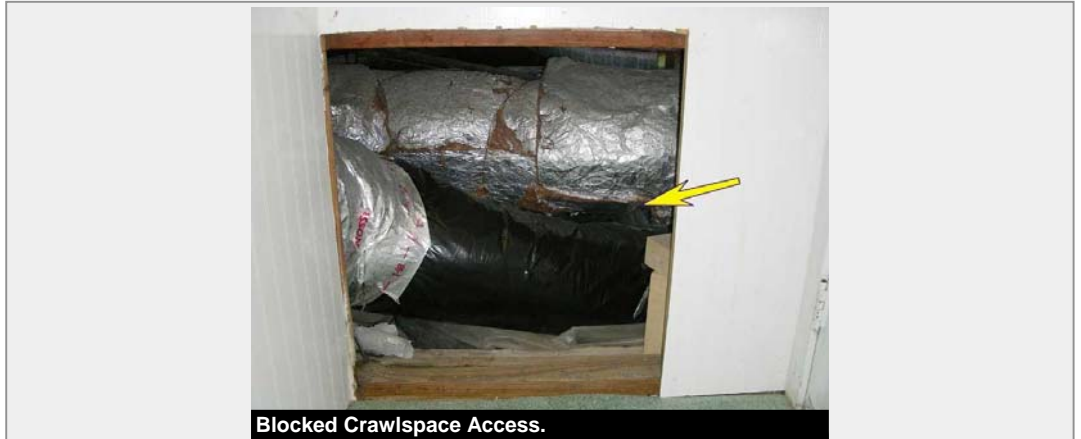
Blocked Crawlspace Access.

- The original crawl space entry was completely blocked by added HVAC ductwork. I was able to enlarge another hole located next to the basement bathroom to gain access, however, **the main portion of the crawl space under the south side of the structure is virtually inaccessible**. I did manage to squeeze through a small opening to view it, but no repairs could be made with the current access. Recommend **cutting a new access door to the crawl space from the rear exterior**. There are repairs and upgrades that need to be done and access to the crawlspace is needed. The access opening for the north side crawl space is also too small and **should be enlarged for easy access**. (*Abandoned ductwork at this entry is also blocking access*).

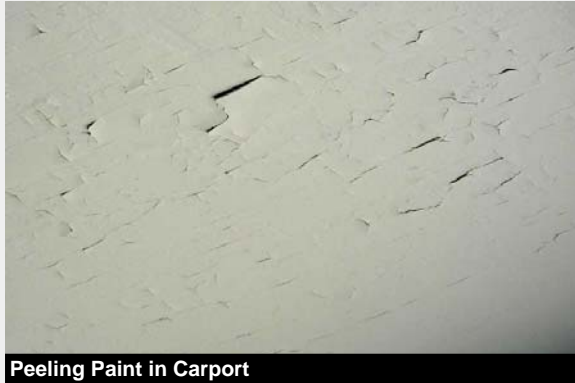
Peeling Paint in Carport

- Noted some peeling paint on the carport ceiling at the left front. This may be due to moist conditions or a roof leak.

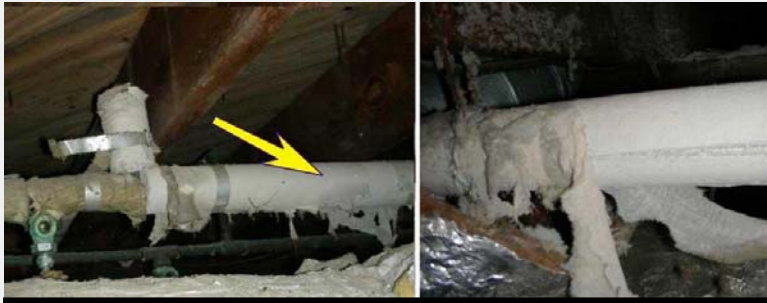
Possible Asbestos Insulation

- Noted an **insulating pipe wrap material that may be made of asbestos**. Took a sample to send to a lab for testing. If material is asbestos, there are two options. 1) Have all asbestos insulation removed (\$\$\$) or 2) Have asbestos material encapsulated by wrapping in tape and sealing with liquid mastic (a duct sealant).

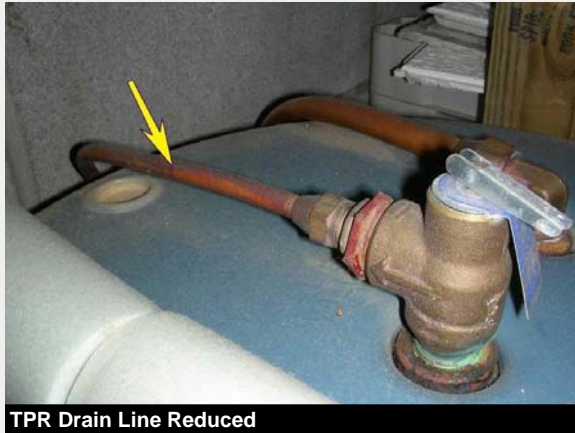
TPR Drain Line Reduced

- The required TPR drain line **is reduced in size**. This is not allowed for safety reasons. Recommend extending TPR drain line full size (3/4") to the exterior.

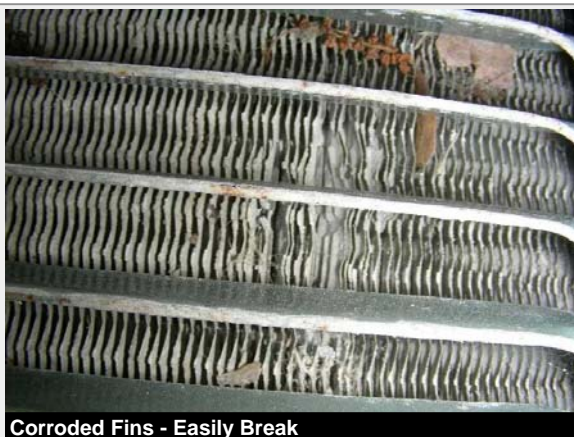
Corroded Fins - Easily Break

- The **cooling fins on this condenser are heavily corroded**. They easily break when touched. Cooling efficiency may be adversely affected by the corrosion. This unit is not protected from a direct sea breeze and the salt appears to have affected the fins. **Unit will need to be replaced within a short time.**

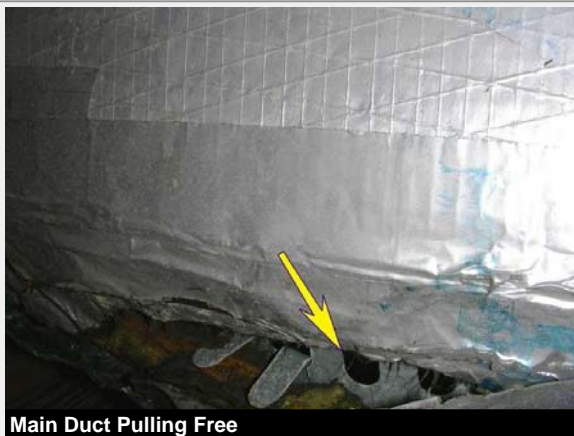
Main Duct Pulling Free

- Numerous **leaks were detected** around the plenum or return. One of the main supply ducts in the basement utility room is **pulling loose and a significant amount of conditioned air is being lost**.

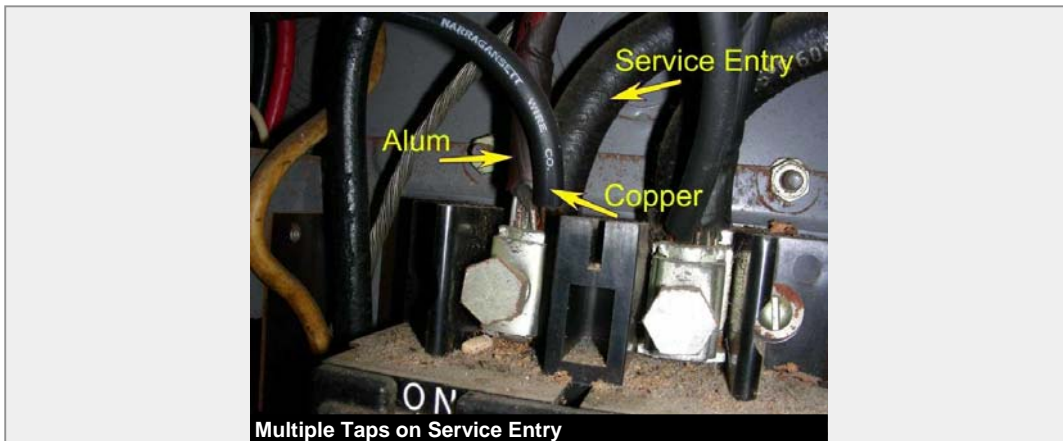
- There are two additional circuits that are **tapped directly to the service feed**. This is not an approved electrical connection. **There should be no other circuits tapped directly to the service conductor feed**. In addition, one of the conductors tapped to the aluminum service feed is a copper conductor. **Copper and aluminum should not be in direct contact with one another**. Recommend repair by a licensed electrician.
- The electrical panel is **old and outdated**. Replacement should be considered.
- There is **inadequate clearance around the electric panel**. Current codes require a 36" working space in front of panels and 30" across.

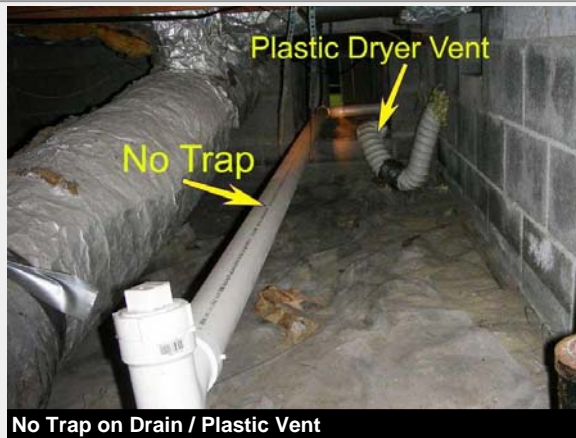
- A plastic dryer vent is installed from the laundry and into the wall. It is against current fire safety codes to penetrate walls with anything except smooth metal venting for dryers. **Plastic material is a potential fire hazard if used in any position for dryer vents.** Recommend replacing dryer vent from laundry room to exterior with smooth metal vent.
- The **laundry drain was installed without a trap.** Sewer gases can escape into the living spaces without a trap. Recommend installation of a trap on the laundry drain.

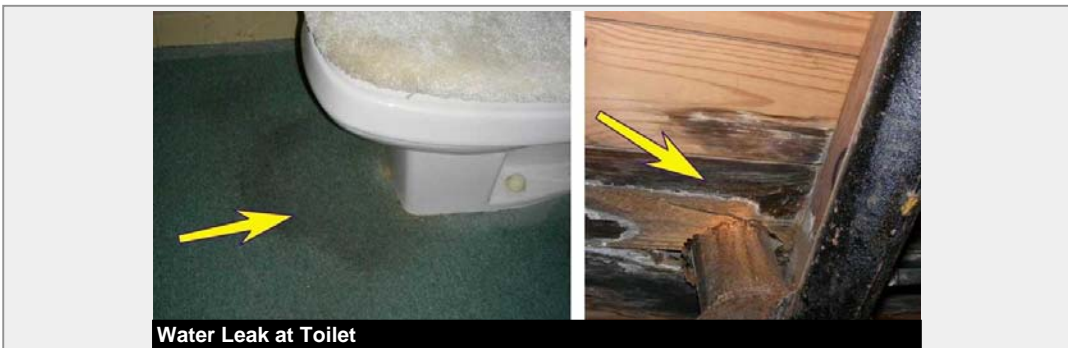
Water Leak at Toilet

- The subfloor appears in satisfactory condition. (** Noted some staining under the toilet in the master bath indicating a water leak - see bathrooms for photo*).
