A Home Inspection Report For the Exclusive Use of:

**1234 New Hope Rd.
Decatur, GA 30033**

Inspected By: **Ted Rodgers**

September 5th, 2006

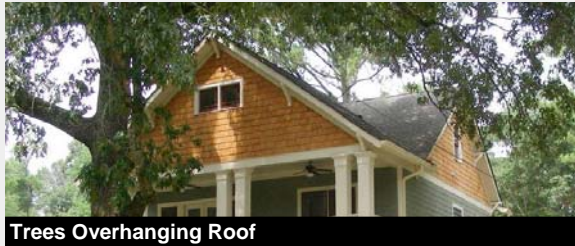
Trees Overhanging Roof

The following problems were noted with some trees.

- There are **trees over hanging the house**. Roof damage may result from falling branches

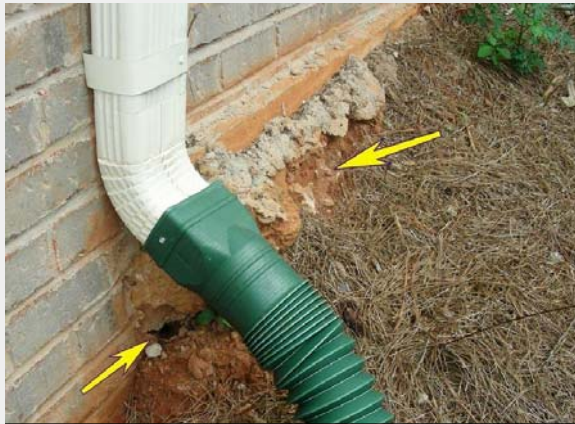
Erosion Under Foundation

- Erosion was noted at at left side front. The **soil has washed out under porch foundation where it meets the house**. Recommend adding a small retaining wall at this location and backfilling against the foundation wall.

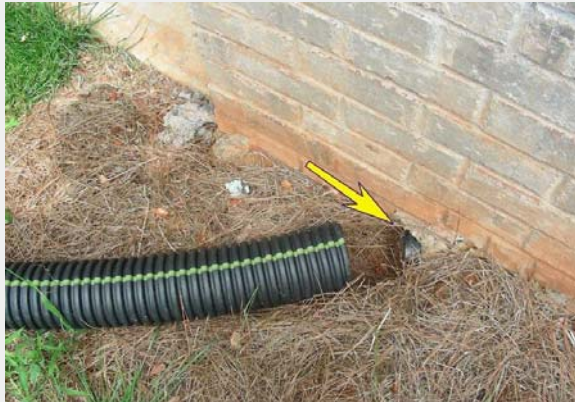
Short Foundation Drain

- The left rear **foundation drain does not extend beyond the foundation**. It has a disconnected section at back left. Recommend extending drain to direct water away from the foundation.

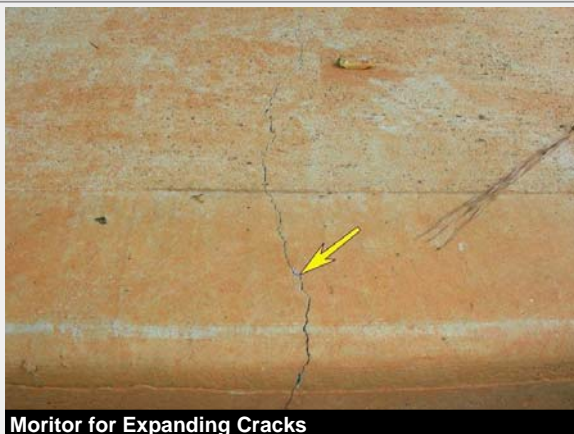
The following problems or deficiencies with the patio were noted.

- The patio has typical cracks. They do not appear significant at this time. Recommend periodic monitoring for changes.

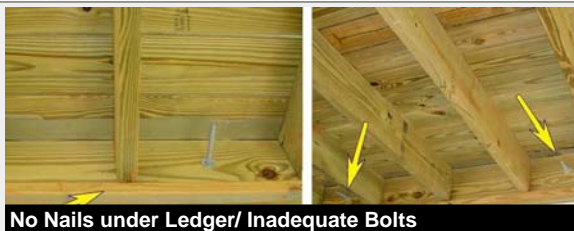
The following problems or deficiencies were noted with the deck.

- Joists are supported by ledger strips. Correctly installed ledger strips **should have 3 nails under each joist**. Recommend adding more nails under joists.
- The **deck is not properly secured to the structure** with an adequate number of lag or carriage bolts. There should be two (top and bottom) 1/2" bolts every 24" O.C. *Reference the Forestry Service Deck Guide that is referenced in the GA building code amendments.*

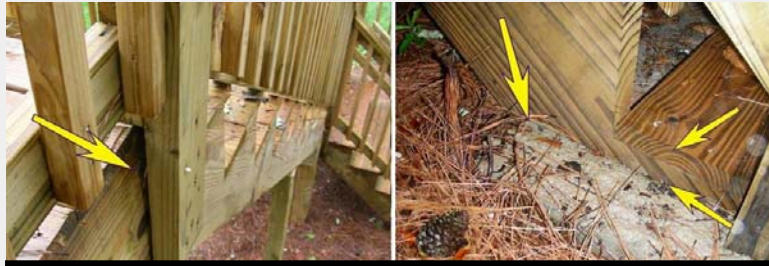
Very Loose Post / Low Step /Ground Contact

The following problems were noted with the rear deck steps.

- The **handrail is loose at the top landing** and needs to be secured. Support posts are easily moved by gentle pressure. **Nails are pulling out.** Recommend 2 bolts be added to all posts.
- The rear steps have an **improper rise and/or run.** The bottom step is not evenly spaced. This can cause tripping on the stairs.
- At base of steps, **stair stringer is in ground contact.** This 2x lumber is **not rated for ground contact** and will not hold up.

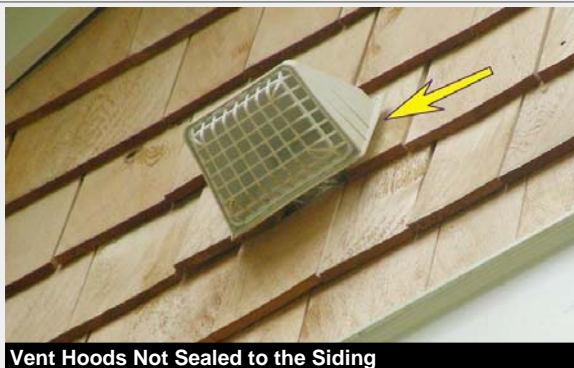
Vent Hoods Not Sealed to the Siding

- Noted **unsealed vent hoods** penetrating the siding. Recommend sealing to the siding with silicone, around all vent hood and faucet penetrations.

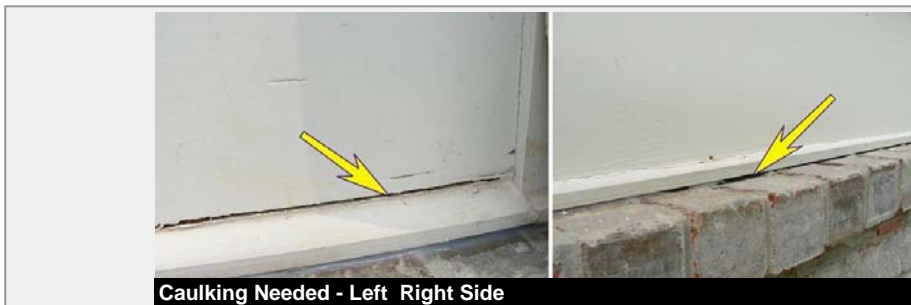
The trim appears in generally satisfactory condition, however:
The following problems or deficiencies were noted.

- The trim needs to be **sealed to the siding** with caulk at numerous locations.
- There are also places at the right rear corner (Upper portion) where **there is missing trim**.

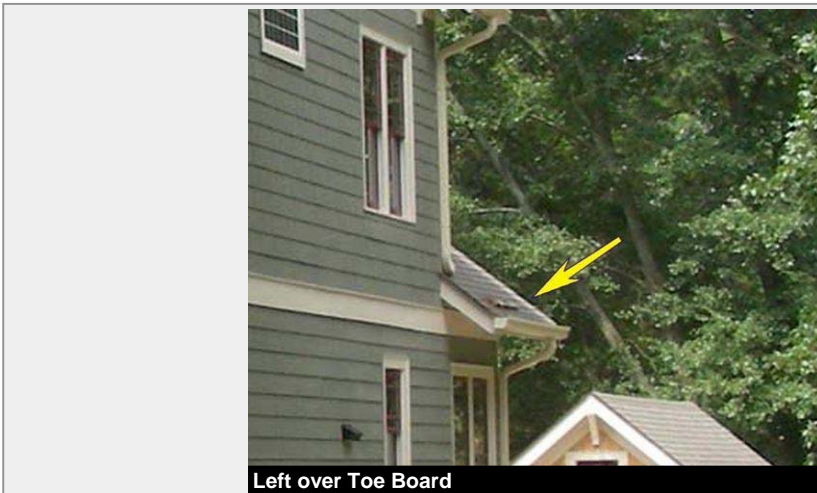
The roof covering is new and appears to be installed properly, however:
The following problems or deficiencies with the roof covering were noted.

- **Toe board holes were noted** at the right rear roof.
Recommend sealing all nail holes to prevent sheathing and/or interior ceiling moisture damage.

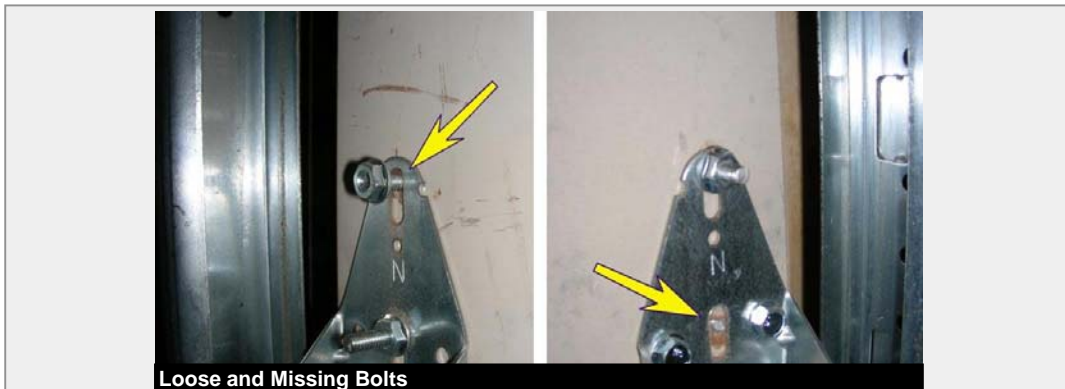
Loose and Missing Bolts

The following problems with the garage doors were noted.

- Adjustment or service is needed to door mechanism. The upper arm that attaches to the door opener chain **stopped past the vertical position**. This made it difficult to open the doors when they were disconnected from the automatic door openers. The **left hand door would not open at all**. I was also unable to make the door opener clip engage the upper arm clip. Recommend installer make corrections as needed.
- Some of the **hinge bolts are loose or missing**. Repair as needed.

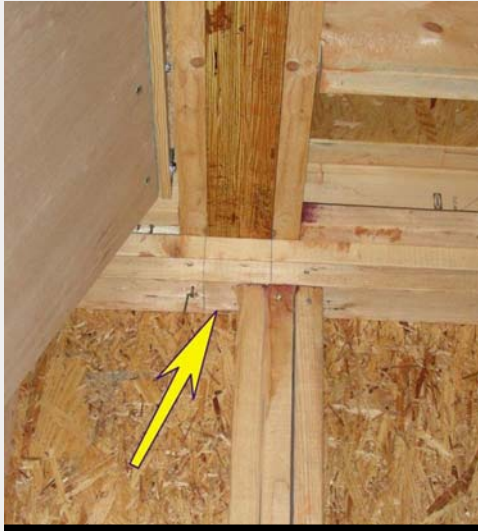
Support Not Under Beam

- Noted that the support studs for the central beam are **not in line with the beam**. Recommend addition of additional stud.

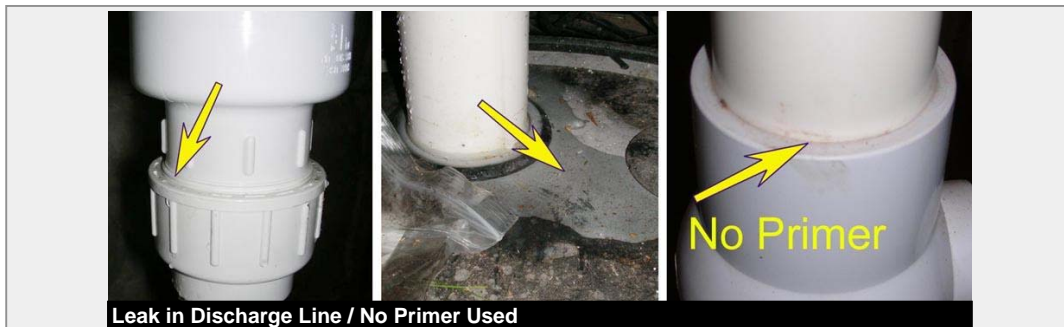
Leak in Discharge Line / No Primer Used

A sewage ejector pump is installed and appears to be working correctly, however:

- No primer was used on the PVC discharge line as required by current plumbing codes.
- There is a leak at a threaded joint in the discharge line from the ejector pump.

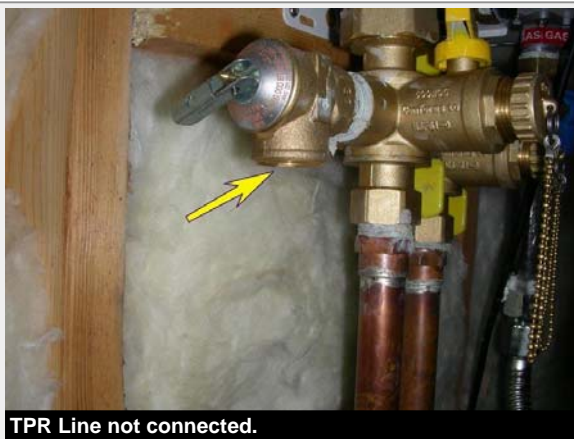
TPR Line not connected.

The following problems or deficiencies were noted with the TPR (temperature/pressure relief) valve.

- The required TPR drain line ends prematurely. There is no drain line connected to the TPR valve. It should extend to the exterior and terminate 6 inches above the ground, pointing downward. This is a safety hazard and should be corrected.

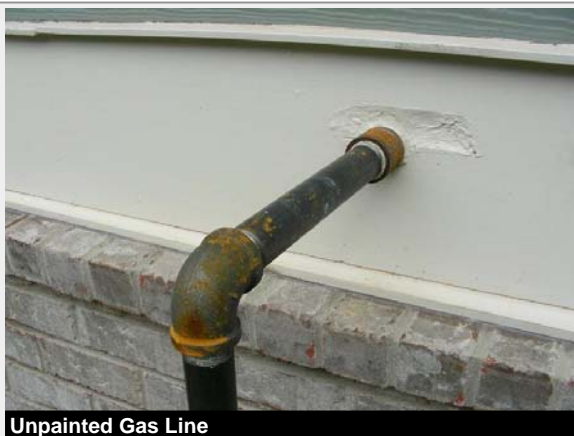
Unpainted Gas Line

- The gas line connecting the gas meter to the house is **very rusty**. Recommend cleaning and painting this line to protect it from weather.

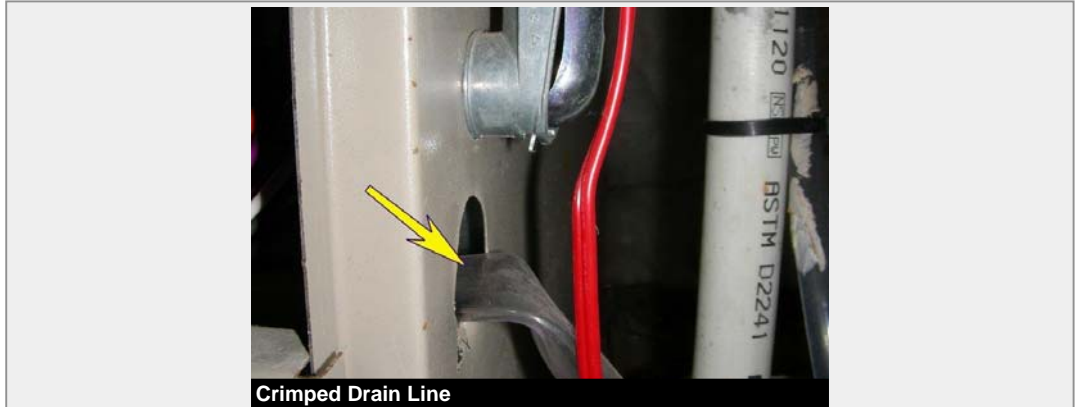
Crimped Drain Line

- Noted a **crimped plastic drain hose from exhaust drain**. This drain is for water that drains out of the furnace exhaust gas. A crimped line may cause the water to back up. Recommend replacement.

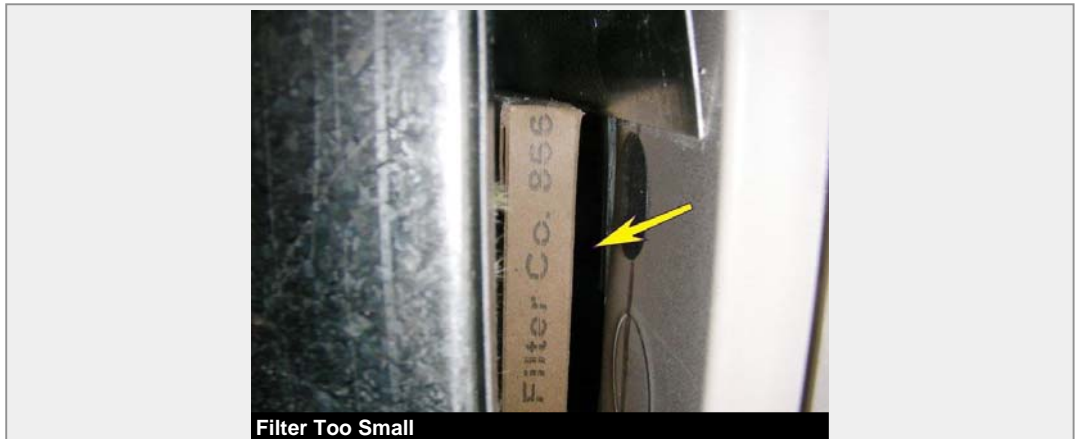
Filter Too Small

The following problems or deficiencies with the air filter were noted.

- The 12x 25 **filter is too small to cover the filter opening**. When seated at the back edge, there is a gap at the front. Recommend a larger size filter of at least 13x26 be used.

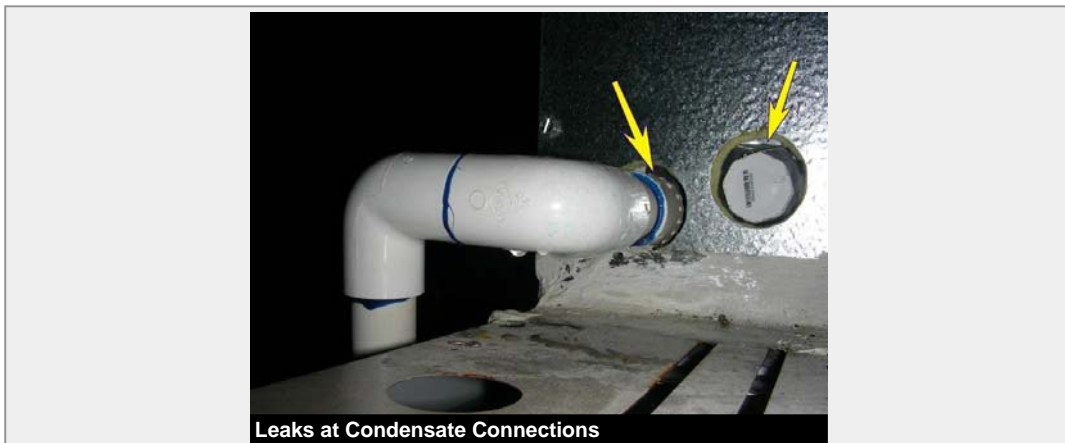
Leaks at Condensate Connections

- Conditioned **air is leaking** from an opening in the cabinet where the **condensate line enters**.
- There are also significant air leaks at the **extra condensate fitting**.
Recommend sealing all openings to maintain efficiency.

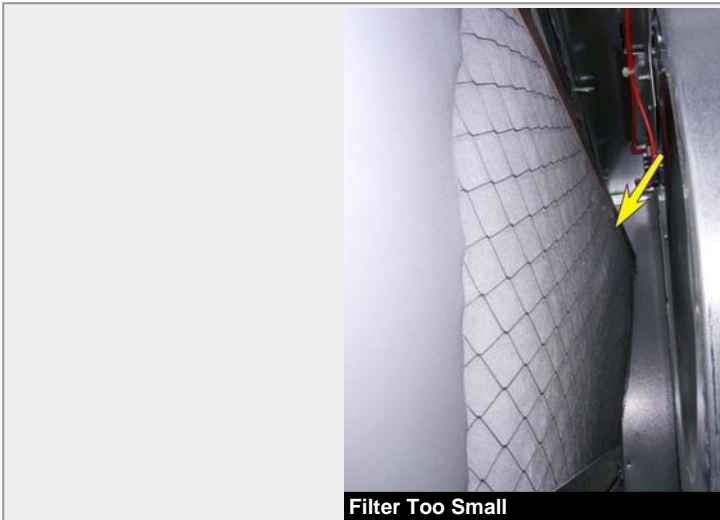
Filter Too Small

The following problems or deficiencies with the air filter were noted.
The following problems or deficiencies with the air filter were noted.

- The 12x 25 **filter is too small to cover the filter opening**. When seated, the filter was **sucked into the blower compartment**. Recommend a larger size filter of at least 13x26 be used.

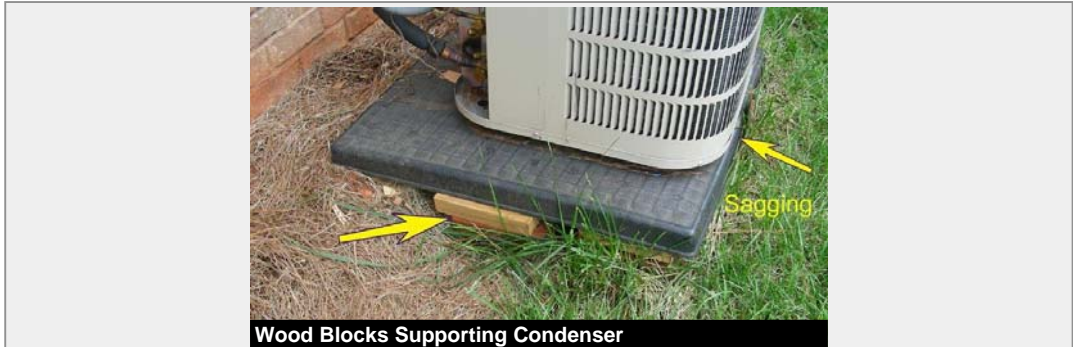
Wood Blocks Supporting Condenser

- Noted that the condenser platform was **supported by wood blocks and also appears to be sagging** at the center. Recommend platform be supported at outer edges by permanent exterior materials.

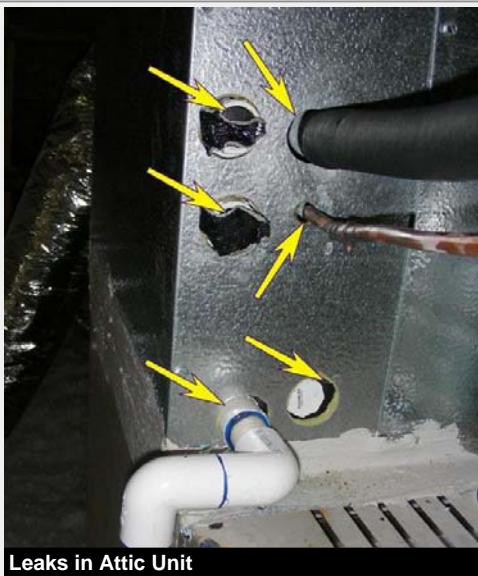
Leaks in Attic Unit

- Air is **leaking from the open nipple attached to the condensate connection** on the cabinet. Recommend installing removable plug on this opening. This opening is not needed for venting, but is merely a cleanout opening.
- Conditioned **air is leaking** from an opening in the cabinet where the condensate line enters.
- Conditioned **air is leaking** from an opening in the cabinet where the refrigerant line enters. Recommend sealing all openings to maintain efficiency.
- Conditioned air is also leaking from the **extra condensate fittings**. These fittings should be plugged.

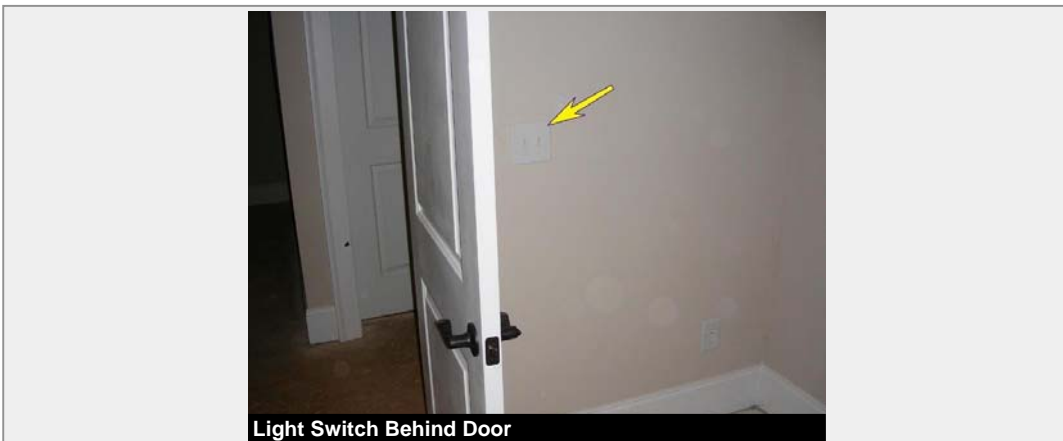
Light Switch Behind Door

- Noted that the light switch for the basement bedroom is **located behind the entry door**. Light cannot be turned on without closing the door.

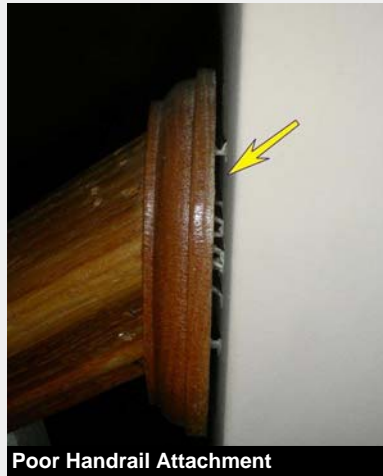
Poor Handrail Attachment

Improvement needed to stairs and/or handrail(s)

- The upper handrail is **poorly attached to the wall**. Large gap visible. Recommend repair as needed.

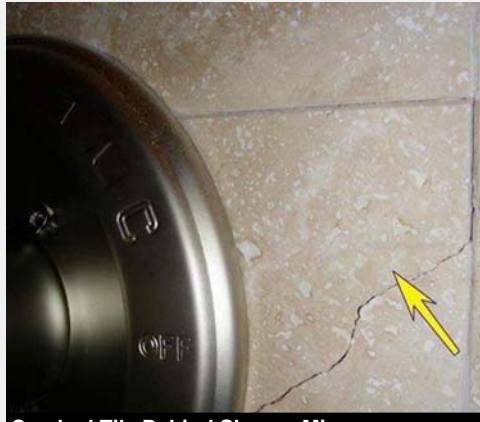
Cracked Tile Behind Shower Mixer

The following problems or deficiencies with the tub/shower walls were noted.

- The tub and or wall surfaces are **damaged**. **Noted a cracked and loose tile** behind the shower control valve. Replace as needed.

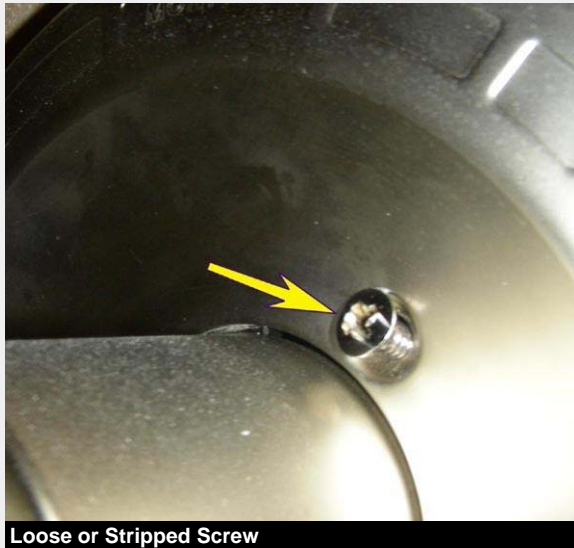
Loose or Stripped Screw

The following problems or deficiencies with the shower fixtures and controls were noted.
